St Marys Cement Inc.

REHABILITATION

**Outstanding Examples by
St. Marys Cement / CBM Aggregates**

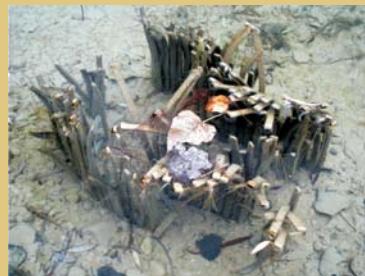
Aquatic Enhancements

To enhance the habitat in near shore areas, CBM recently installed Aquamats to the ponds.

The Aberfoyle pit has been in operation since the 1950's and progressive rehabilitation has returned portions of the site to a naturalized state. In the late 1970's, trees were planted which are now large and mature, providing wildlife habitat and ecological diversity. Rehabilitation along the edges of the pond areas has been designed to support fish species such as trout and bass. To enhance the habitat in near shore areas, CBM recently installed Aquamats in the ponds.

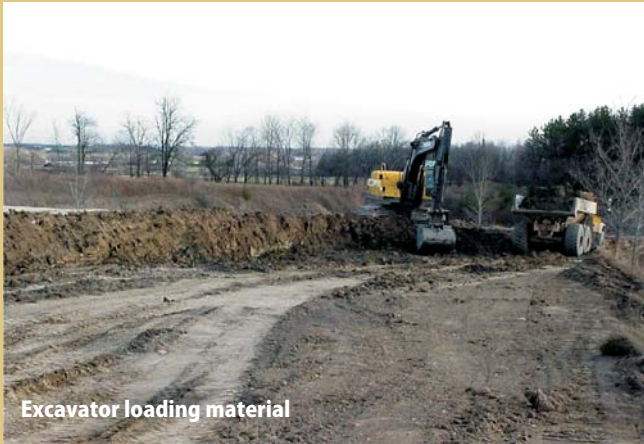
Excavator loading material

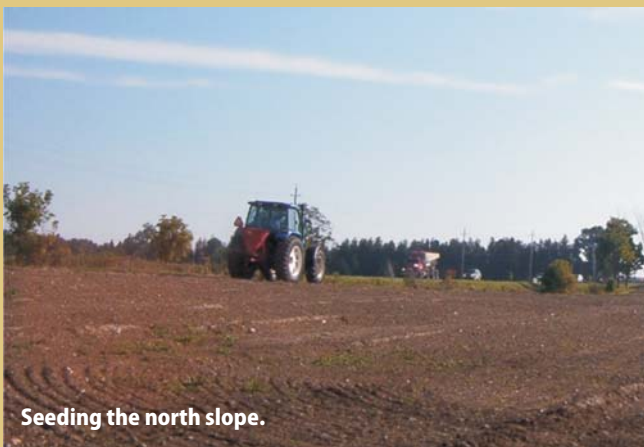
Seeding the north slope.

- ▶ Grading the setbacks around the extraction area to create gentle side slopes.
- ▶ Replacing the topsoil using material that was stored on site.
- ▶ Harrowing and seeding the area to re-establish ground cover.

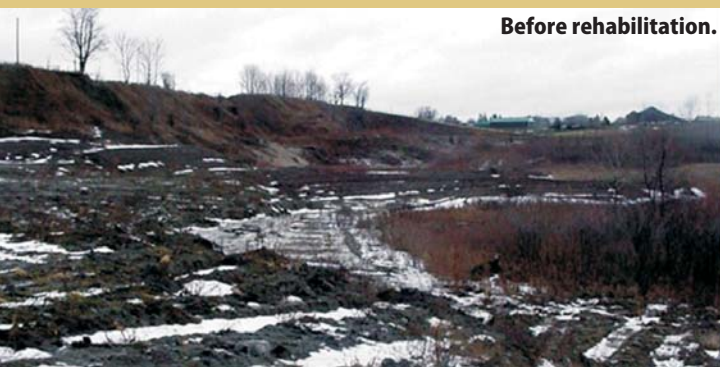
Before rehabilitation.

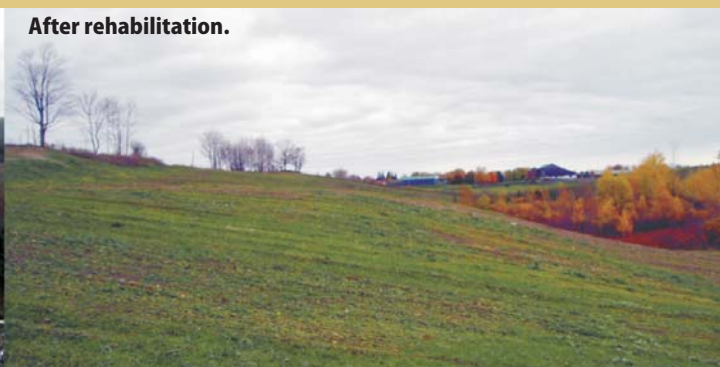
After rehabilitation.

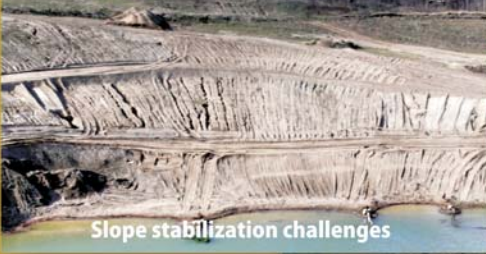
Slope stabilization challenges

- ▶ Stabilizing the slopes by creating terraces and several trenches that were lined with filter cloth and boulders. The terraces were designed to slope inward, catching water and directing it into the trenches. Channeling the water into the appropriate drainage locations greatly minimized the amount of soil erosion.

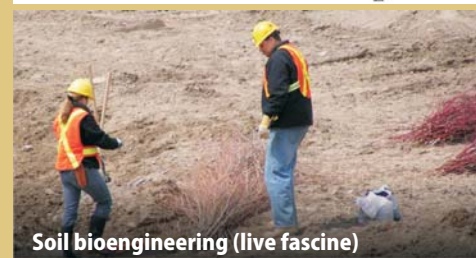
Soil bioengineering (live fascine)

- ▶ Soil bioengineering (live fascine) to stabilize the high water line and develop a shrubby riparian cover.
- ▶ Creating new habitat diversity by utilizing logs and rocks to add structural diversity and these created micro-habitat diversity.

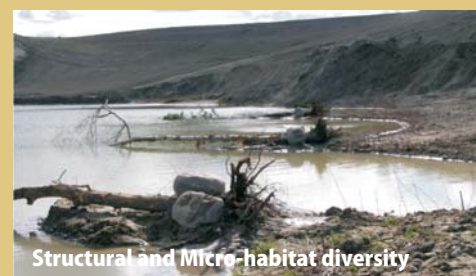
Structural and Micro-habitat diversity

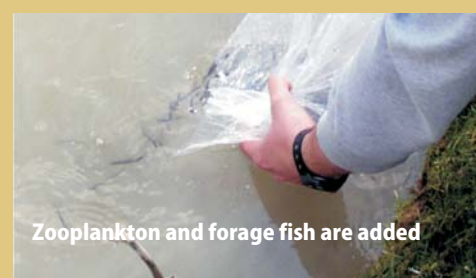
Zooplankton and forage fish are added

- ▶ Zooplankton, forage fish and predators were added to the lake sequentially as each population stabilized.
- ▶ Hydroseeding the slopes in 2003 and again in the spring of 2005.

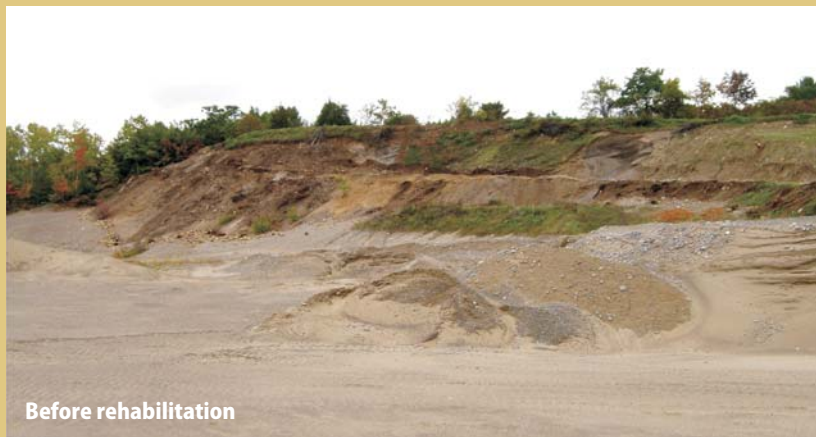
Before rehabilitation

CBM Aggregates McDonnell Pit, located in Murray Township, Northumberland County, began operation in the spring of 1991. When extraction was complete along the northeast floor and face, the slope was steep. The area rehabilitated was 2.7 hectares.

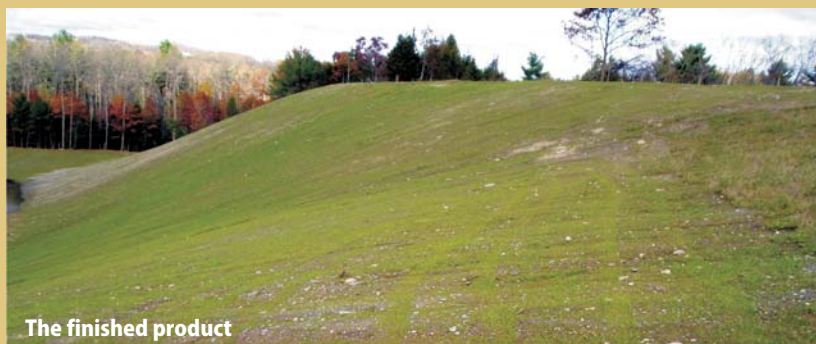
The finished product

- ▶ Stabilization and grading of the northeast floor and face began in September 2005. The project was completed a year later.
- ▶ A new gentler side slope was created, as the old extraction face was benched from the bottom up.
- ▶ Once the slopes were established, the overburden and topsoil were spread and fine graded.
- ▶ A seed spreader distributed seed over the 2.7 hectare area.
- ▶ The seed mix consisted of 20% Perennial Ryegrass and 80% Red Fescue.
